**AVIATION INVESTIGATION REPORT
A03A0002**

COLLISION WITH WINDROW

**LABRADOR AIRWAYS LTD.
BEECH 1900D C-GLHO
ST. JOHN'S INTERNATIONAL AIRPORT
NEWFOUNDLAND AND LABRADOR
11 JANUARY 2003**

Report Number A03A0002

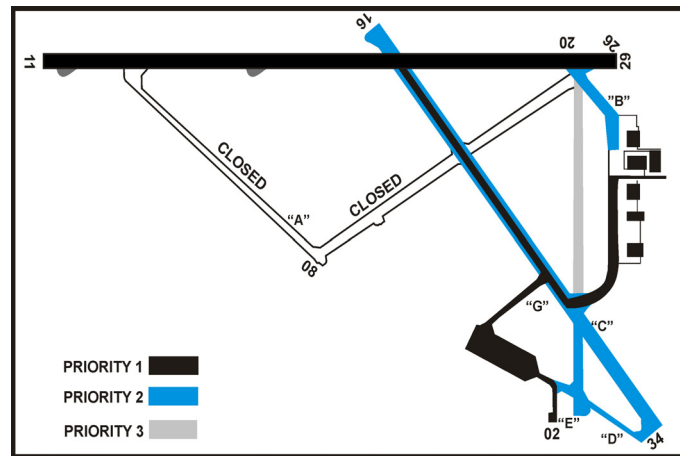
Figure 1. Snow Clearing Priorities with Runway 11/29 Active

St. John's Airport is a certified, controlled airport. The airport has three runways - 11/29, 16/34, and 20/02, and all three runways are used throughout the year. Snow removal and winter runway maintenance priorities are established in the St. John's Airport Winter Maintenance plan. Because of its Category II instrument approach capability, and unless wind conditions clearly favour Runway 16/34, snow clearing efforts are initially focussed on preparing Runway 11 and the associated runways and taxiways that are necessary for access. The various airport surfaces are designated under one of three priorities for snow clearing (see Figure 1). Priority 3 surfaces are cleared last. Runway 02, north of taxiway Charlie to the entrance to taxiway Bravo, is designated as a priority 3 surface when either Runway 11/29 or 16/34 is active.

Runway 02 north of Charlie is a low-priority surface, and was not used prior to Lab Air 8333 by either vehicles or aircraft. The surface had not been cleared, was not usable, and was not necessary, yet it remained open. The St. John's Airport winter maintenance plan does not contain guidance to field maintenance personnel for the closure and subsequent re-opening of these non-essential surfaces.

The St. John's Airport Authority has issued a memorandum which allows the lead hand to close Runway 02/20 when conditions require.

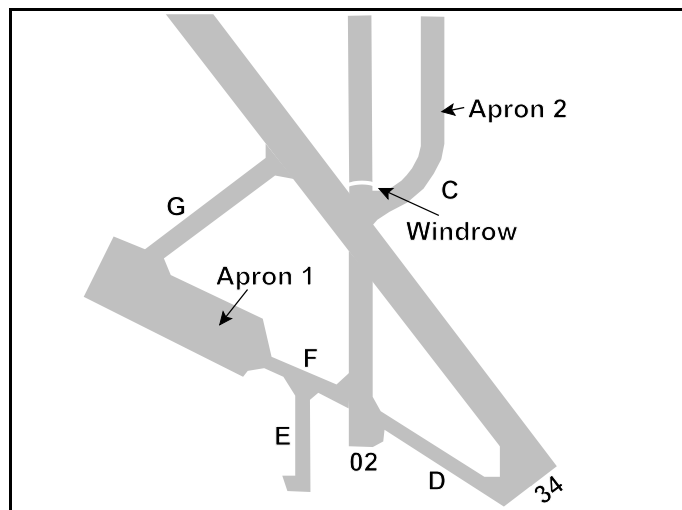
Figure 2 - Taxi Routing

At 0841, Lab Air Flight 8333 was cleared to taxi via Foxtrot, Runway 02, and to hold short of Runway 29 (see Figure 2). An analysis of the flight data recorder (FDR) information showed that the aircraft was travelling at about eight knots and was accelerating when it rolled out on the runway, heading on Runway 02. As the aircraft approached the intersection of runways 02 and 34 there were several snow removal vehicles on Runway 34 east of the intersection. After confirming that the vehicles were holding short, the crew proceeded through the intersection, initiating the "instruments" portion of the taxi check nine seconds prior to striking the windrow. According to the operator's standard operating procedures for the instrument cross-check, the captain (pilot flying), must look inside the cockpit to call out indications from the aircraft's flight instruments. Meanwhile, the first officer (pilot not flying) is supposed to also monitor the instruments and when found correct will respond "Checked and Set Left/Right."

As the crew were conducting this check, the windrow was spotted. The aircraft was now 3.5 seconds and 146 feet² from the windrow and travelling at 24 knots. The captain attempted to stop with wheel braking, approximately two seconds later and 60 feet short of the windrow. When the wheel brakes were applied, the aircraft started to skid on the slippery runway surface. The captain attempted to apply reverse thrust, but there was insufficient time for it to be selected before the nosewheel struck the windrow, at 23.5 knots. The propellers struck the windrow next, followed one quarter of a second later by the main gear, which struck the windrow at approximately 20 knots.
